Clontarf / Bantry Bay

**Data Compilation
&
Estuary Processes Study**

FINAL REPORT

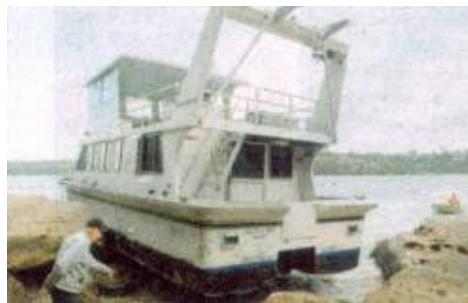
The study area experienced waves, high winds and significant siltation. Many trees were down. Seaforth residents experienced power cut after a tree fell on power lines. A cruiser washed ashore at Clontarf.

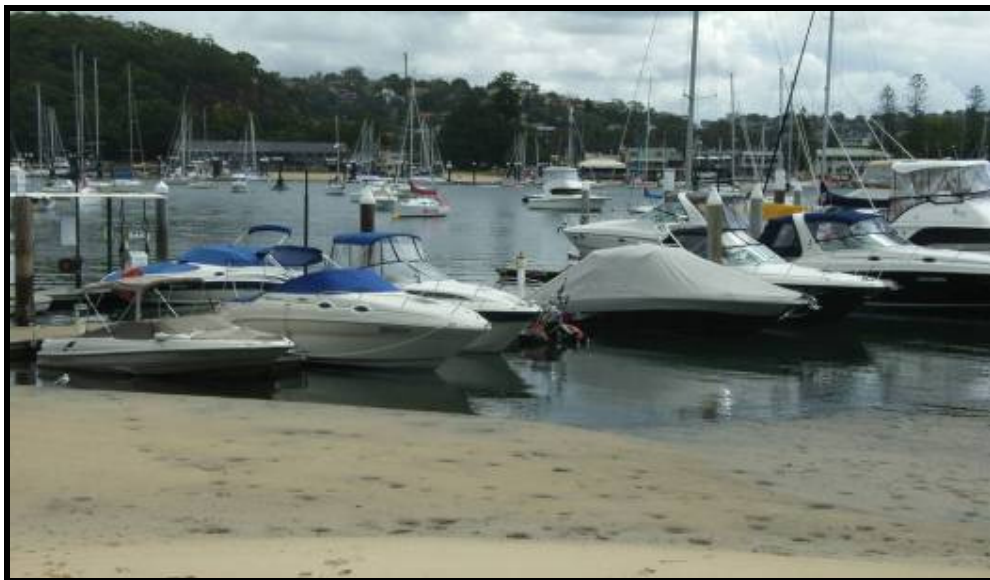
Figure 3.8.1c – Boats Berthed in the Steep Beach Drop-off Surrounding Clontarf Marina

The marina at Clontarf lies directly in the path of the sand transport corridor between the tidal delta and Sandy Bay. However, the beach profile appears to have been modified from its natural state, due to the irregular shape of the shoreline between Clontarf Reserve and Sandy Bay. The large sand flat of Sandy Bay transforms into a narrow beach with a steep drop-off on either side of Clontarf Marina, and then back into a sand flat to the south of the marina (see Figures 3.8.1b & 3.8.1c).

There are many forces impacting on this part of the estuary, creating a complex system. Along with the sand transport corridor, there is a large stormwater outlet that discharges immediately to the east of Clontarf Marina (see Figure 3.8.1b). Many boats move in and out of the bay to access the marina and moorings, with their associated propeller wash and wake contributing to sediment transport. The overall result of all of these forces cannot be confirmed with the limited information available (see section 6.3).

One possible scenario is that dredging occurs at the marina to maintain sufficiently deep access for boats to their berths, and the natural beach profile would be a continuous sand flat between Clontarf Reserve and Sandy Bay – indicated by the blue line in Figure 3.8.1b. In the past Clontarf Marina undertook 'propeller wash maintenance operations' to maintain navigable depth around the marina. This was done by securing a boat at the bow, and using the wash from the propeller at the rear to flush sand away. It is noted that this was done in the direction of the natural sand transport corridor. However, a small spit-like bar on the seaward boundary of the Sandy Bay sand flat indicates the line of transport of sand into Sandy Bay. This appears to support the scenario that the beach profile may naturally follow the blue line, and that the spit would normally extend parallel to the shore to Clontarf Beach (GSE, 1990). In this scenario, artificial displacement (eg- propeller wash operations, dredging, or through the constant movement of boats) of sand would appear to be the only reason for the deep hole that exists on each side of the marina.

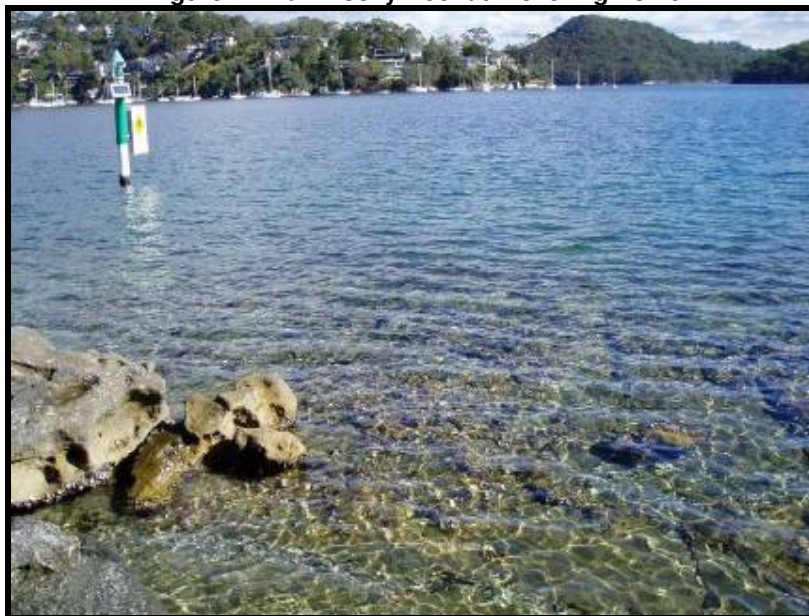
Figure 4.1.1a - Rocky Reef at Pickering Point

There is an abundance of rocky shores and reefs (Figure 4.1.1a) throughout the study area, mostly adjacent to the headlands of the various bays. The reefs provide valuable shelter, such as caves and crevices, and also a food supply, for various marine species. Crustaceans and invertebrates live on the rocks, and fishes that feed on them live in the surrounds. These rocky areas also contain patches of kelp beds, which provide vertical underwater structure and much valuable habitat and also a source of food for certain marine species. Kelp is a form of macro-algae, with anchors to hold it onto the rocks rather than a formal root system.

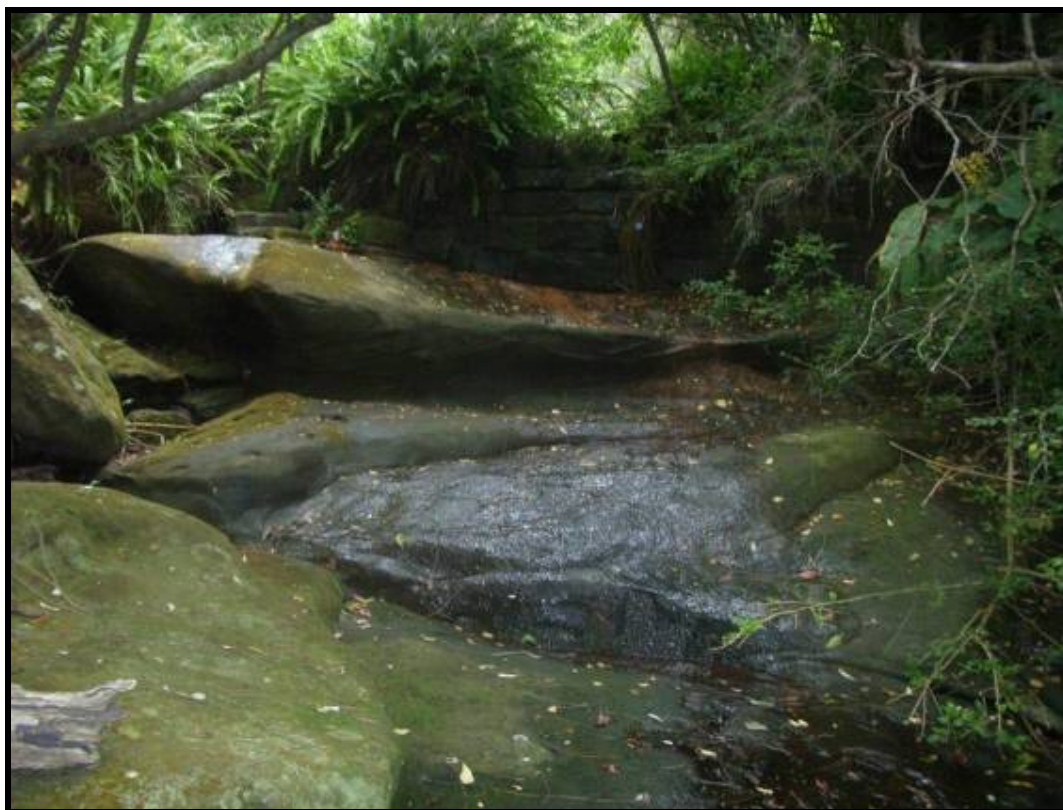
Figure 4.3.1d – The Bottom of the Sangrado Street Watercourse with Weir in Background, 2007

the weir was erected, although it is likely a remnant from the house that was located in Sangrado Reserve until the 1970's (McAteer, 2006).

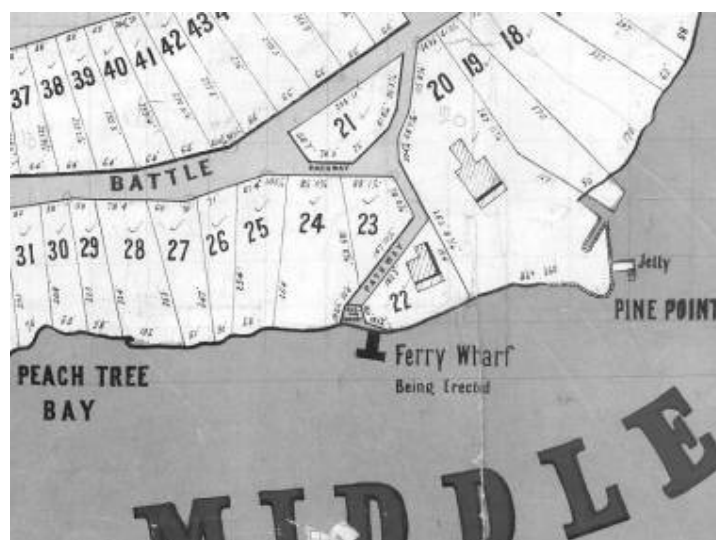
Figure 5.1.4a: Laura Street Ferry Wharf as shown in 1906 Seaforth Subdivision Plan

Besides, there is remnant of a 1906 wharf located off Laura Street, Seaforth. The wharf site is not heritage listed. As the record goes, *"In 1906 Henry Halloran envisaged a ferry service to the city from a wharf at the bottom of stairs that go down from Seaforth Crescent alongside Laura Street. It is shown on the 1906 Seaforth subdivision plan as "under construction" (Figure 5.1.4a). "It will not take Seaforth long to have a fleet of regular ferry steamers equal to Manly's", stated Halloran's publicity."* The ferry did not eventuate.

Scan 9.8.07 From Halloran's 1906 Seaforth subdivision plan

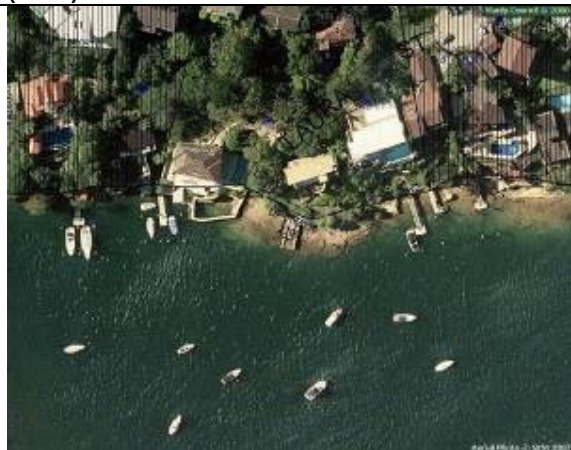
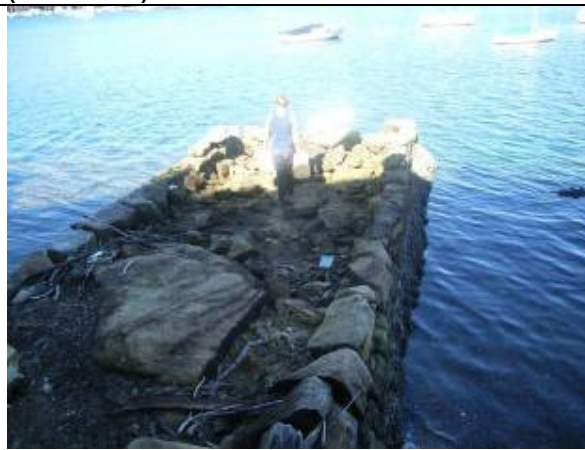
Laura Street Wharf site is still used by boat users (Figures 5.1.4 b and c). Laura Street Wharf is used by mooring licensees for Seaforth to store their dinghies, as there is no other public access (personal communication, Anita Robinson, NSW Maritime).

**Figure 5.1.4b. Aerial View of Laura Street Wharf (2007)**

**Figure 5.1.4c. Remnants of Laura Street Wharf (08/08/2007)**

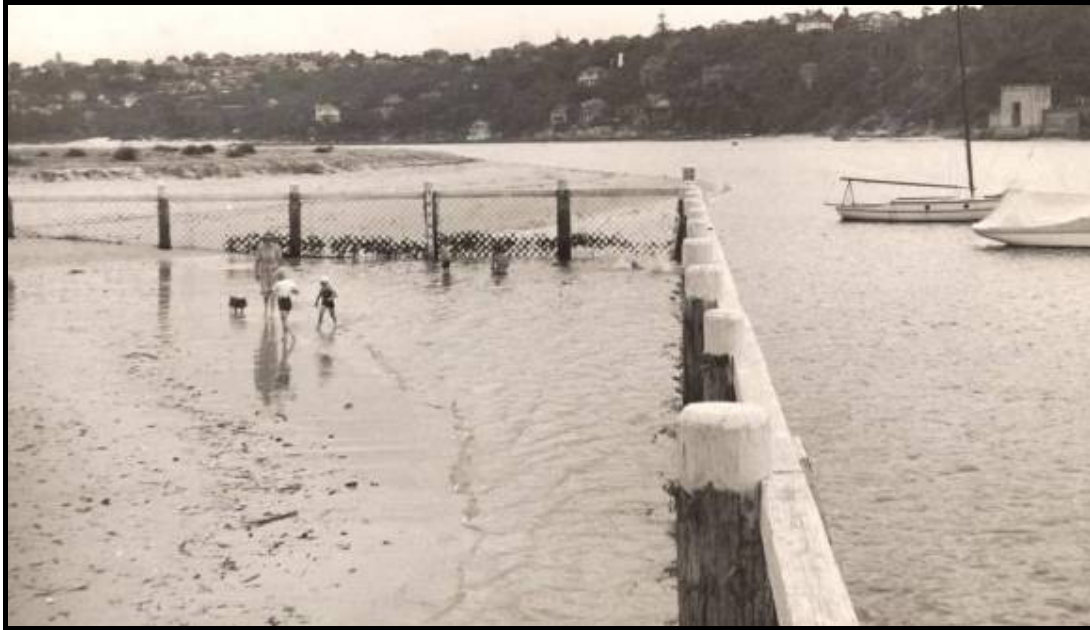
Figure 5.1.6a - Clontarf Swimming Enclosure at Low Tide, 20/12/1949

Clontarf Swimming Enclosure: The swimming enclosure at Clontarf Beach is used regularly by the thousands of locals and tourists who visit the Beach every year. However, at low tide there is so little water in the pool that it is virtually unusable (Figures 5.1.6a & 5.1.6b).

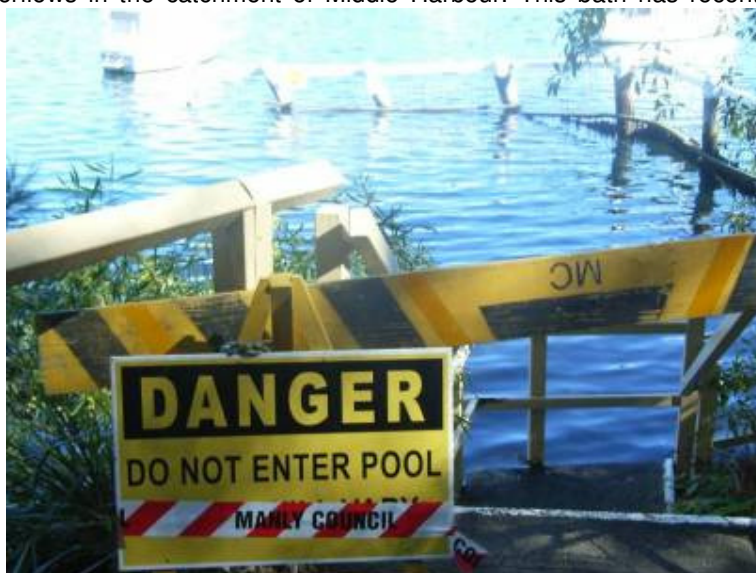
However, all these swimming enclosures are subject to significant marine growth, particularly oysters. The oysters cover not only the enclosures themselves, but also the steps leading into the pools, and the floor of the pools. This has made these pools also virtually unusable, due to the dangers associated with the extremely sharp oysters. Periodic removal of oysters would likely be a relatively simple and effective process, although approval from DPI would be necessary due to the area being part of the Intertidal Protected Area (see section 4.2.1 above).

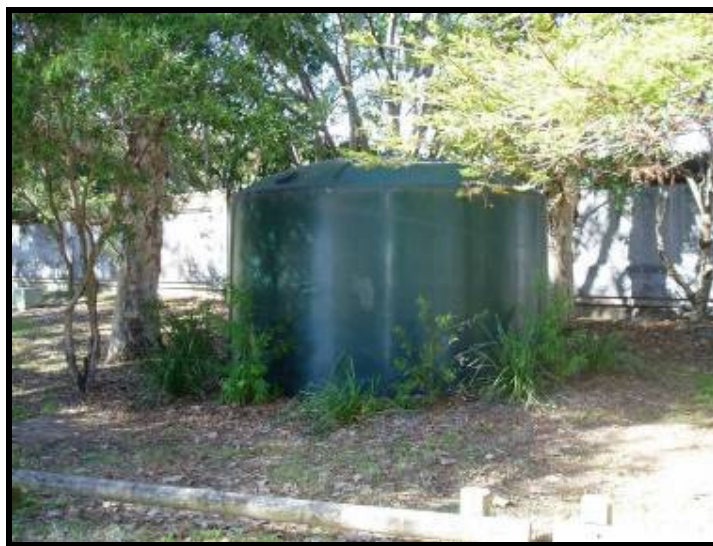
Figure 5.2.1 – Groundwater Storage Tank at Clontarf Reserve

Irrigation is undertaken through 70 sprinkler heads around the reserve, which each distribute 15 litres per minute, and are used for three 10 minute runs per week. Total groundwater consumption at Clontarf Reserve is therefore:

$$70 \text{ sprinkler heads} \times 15\text{L per head per minute} \times 3 \text{ runs per head per week} \times 10 \text{ minutes per run} \\ = \mathbf{31,500 \text{ litres per week}}$$
