**Clontarf / Bantry Bay**

**Data Compilation  
&  
Estuary Processes Study**

**FINAL REPORT**

**Part – II (Chapters 6 -12)**

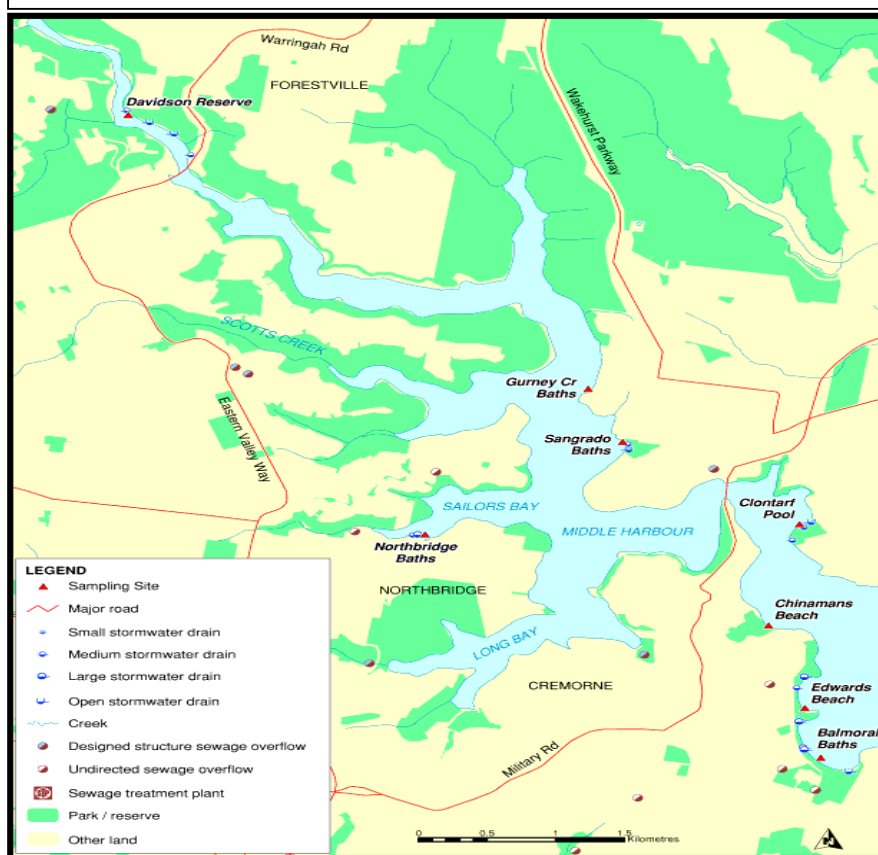
**Figure 6.1.3a Harbourwatch sampling Locations within Middle Harbour**  
Source: DECC 2006

Random grab sampling undertaken for the Spit Bridge Widening Statement of Environment Effects indicated that water quality generally fell within the ANZECC Guidelines recommended for estuarine and marine habitats (GHD, 2003). However, the most comprehensive measured water quality data identified was through the Harbour watch program, run by the Department of Environment and Conservation. The Harbour watch program's key concern is human health relating to the use of harbour waters, and as a result it focuses primarily on bacterial pollution (Department of Environment & Conservation, 2006). Hence, the two major indicators of bacterial contamination, *faecal coliforms* and *enterococci*, are measured at various harbour swimming locations. Faecal coliforms and Enterococci are found naturally in the intestines of humans and therefore also in the sewerage system, so are used to indicate the presence of sewage pollution. Sampling locations within the study area are Gurney Crescent, Sangrado Baths and Clontarf Pool (see Figure 6.1.3a below).

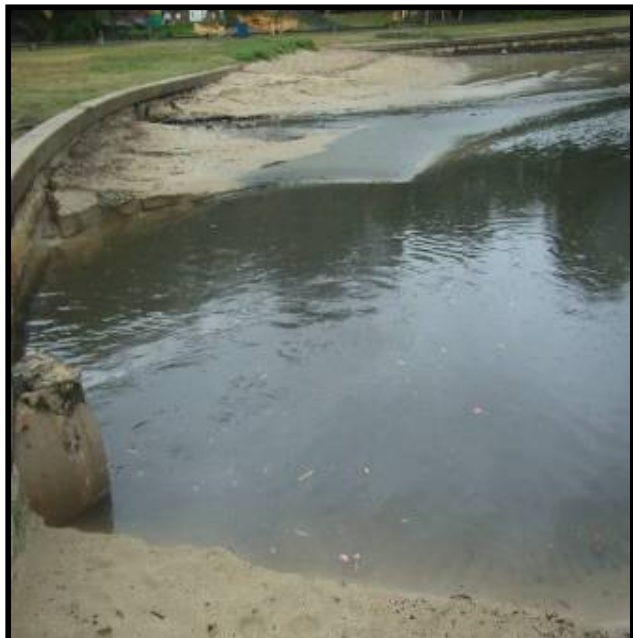
**Figure 6.1.3d – Stormwater Pollution at Sandy Bay, 12 February 2007**

Although further water quality monitoring data is not available for the study area, there is visual evidence of other types of pollution on occasions. Figure 6.1.3d shows stormwater entering Sandy Bay during a heavy rain event on 12 February, 2007. Visible pollution includes organics, litter and sediment, and likely some dissolved pollutants due to the dark colour of the stormwater. Figure 6.1.3e shows an algal bloom adjacent to Clontarf Marina in 2003. The bloom could have been a result of high nutrient levels due to human activities, but it is also possible that it was a result of natural environmental factors. Figure 6.1.3f shows a sewage leak on the Manly Scenic Walkway, directly above Castle Rock Beach at the south-eastern end of the study area. Figure 6.1.3g shows a plume of suspended sediment adjacent to Castle Rock Beach, after a burst water main eroded and transported sediment into Middle Harbour from high up in the catchment.

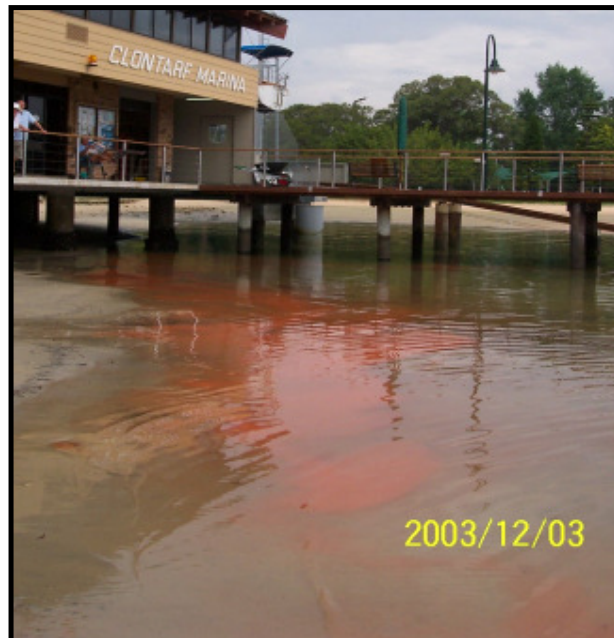
**Figure 6.1.3e - Algal Bloom at Clontarf**

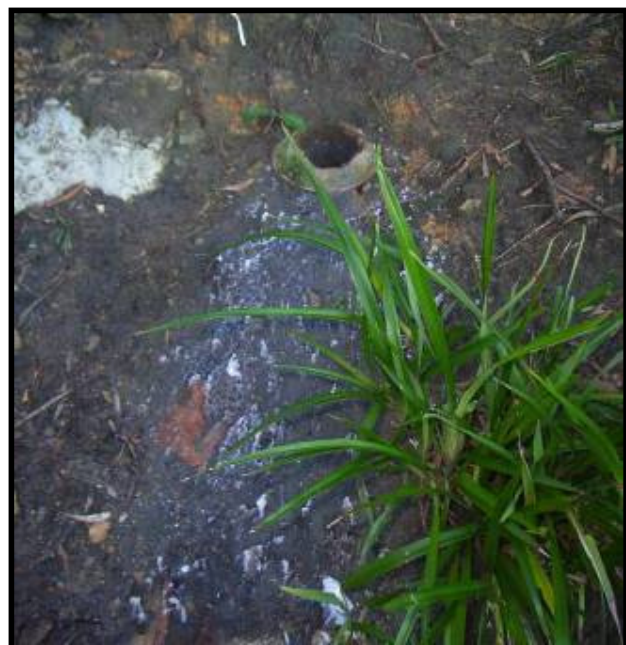
**Figure 6.1.3f – Sewage Leak on the Manly Scenic Walkway**

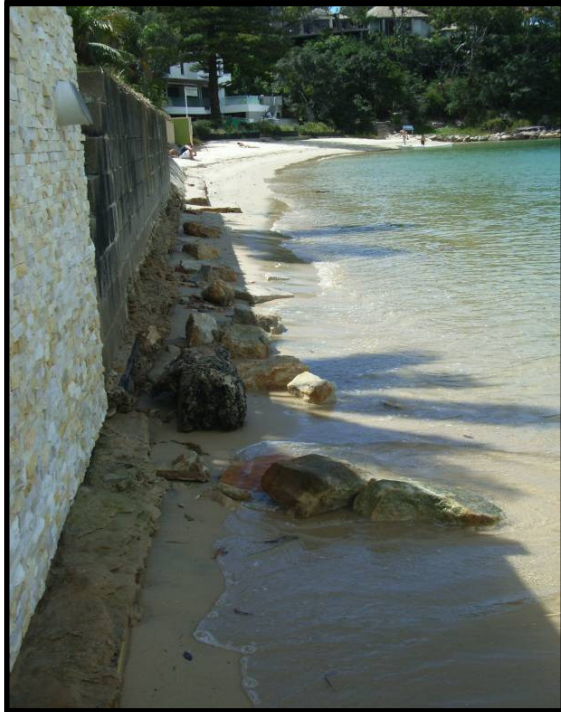
**Figure 6.4.1b**  
**Beach Erosion at Clontarf Beach,**  
**5/12/2006**

as wave energy is reflected. It is clear that accretion is indeed also taking place, as the photos taken in July and January 2007 show noticeably more sand covering the rocks than the photo taken in December 2006 (see Figures 6.4.1b & 6.4.1c & 6.4.1d).

Not only do the vertical structures built parallel to the beach (eg- the seawalls and garden beds at Clontarf Beach & Sandy Bay) limit the supply of sand to a beach during periods of erosion, they can also actually exacerbate the erosion processes. On a natural beach profile, wave energy in normal (i.e.- calm) conditions is dissipated gradually as it runs up a sloping beach, and is also absorbed as water percolates through the sediment. When waves are instead abruptly stopped by a vertical structure, all of the wave energy is focused in one spot at the base of the wall, resulting in the erosion of sediment (Piorewicz, 2007). At high tide along Clontarf Beach and Sandy Bay, the water level is high enough for this process to occur, as indicated in Figure 6.4.1b.

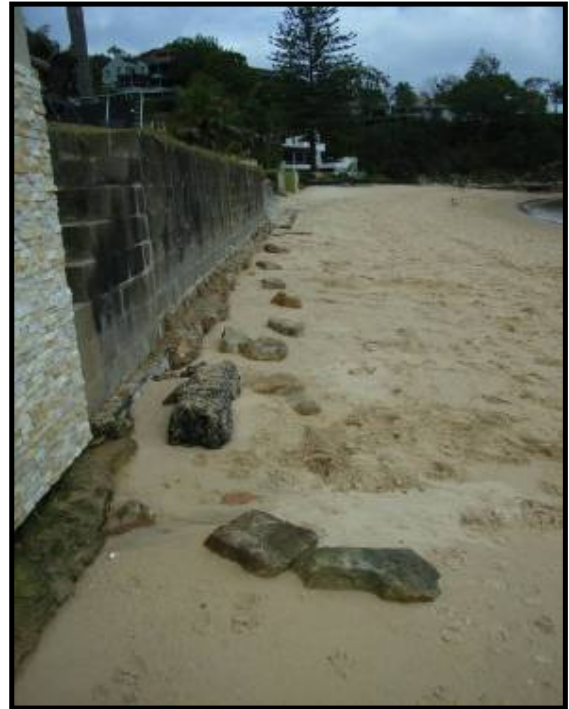
**Figure 6.4.1c**  
**Beach Siltation at Clontarf Beach**  
**3/1/2007**

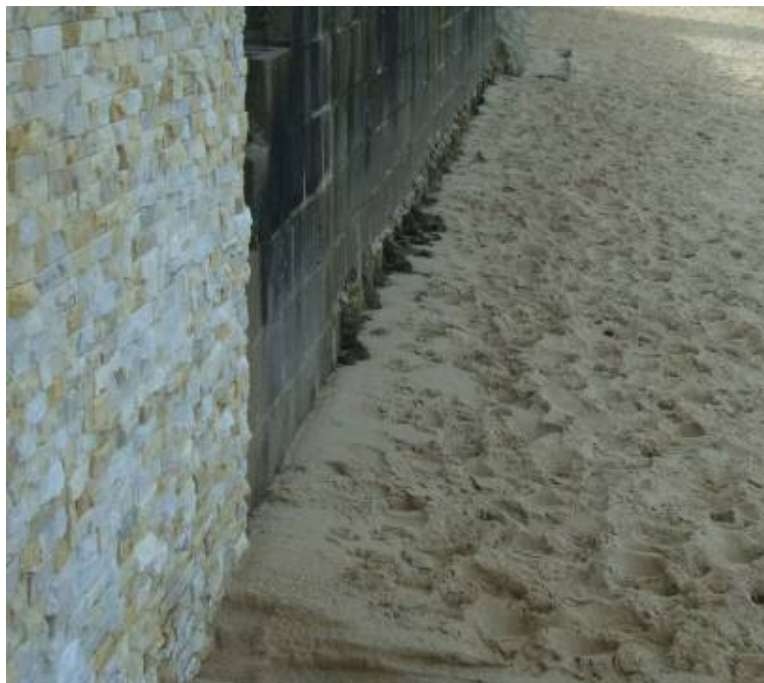
**Figure 6.4.1d**  
**Beach Siltation at Clontarf Beach 24/7/2007**

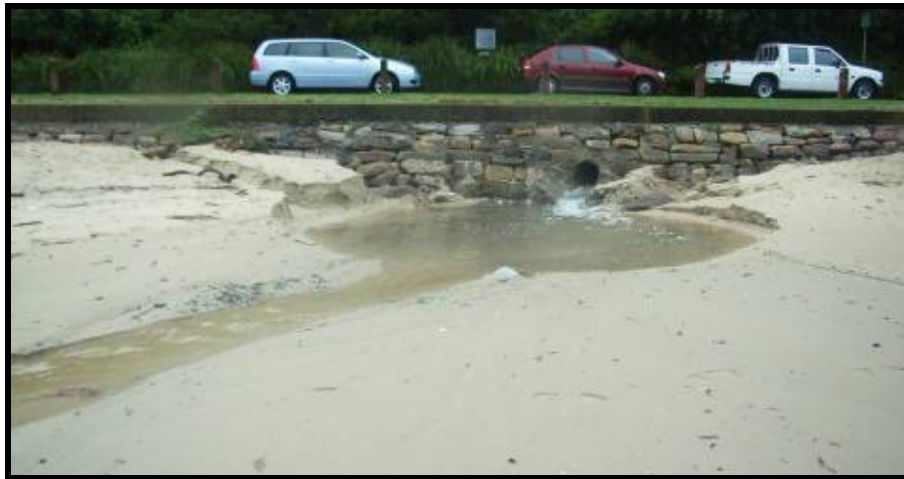
**Figure 6.4.2b – Stormwater Erosion at Sandy Bay, 12/02/07**

In the study area, the relatively narrow and steep catchment means that nearly all of the major stormwater pipes extend right to Middle Harbour, and discharge either onto the foreshore or directly into the water (see Figure 6.4.2a). The pipes that discharge directly into the water or onto the foreshore, generally pose erosion problems. Some of the pipes direct flows over rock, which provides a stable surface that is not easily eroded, but many of the pipes direct flows over the sandy beaches, which can result in erosion. Figure 6.4.2b shows a stormwater pipe at the rear of the beach in Sandy Bay during a storm in February 2007, with significant erosion resulting from the flows. Large volumes of sand have been removed from the beach, and the base of the seawall has also been exposed, potentially compromising the integrity of the seawall. This can further exacerbate other erosion processes such as those mentioned in section 6.4.1 (above).

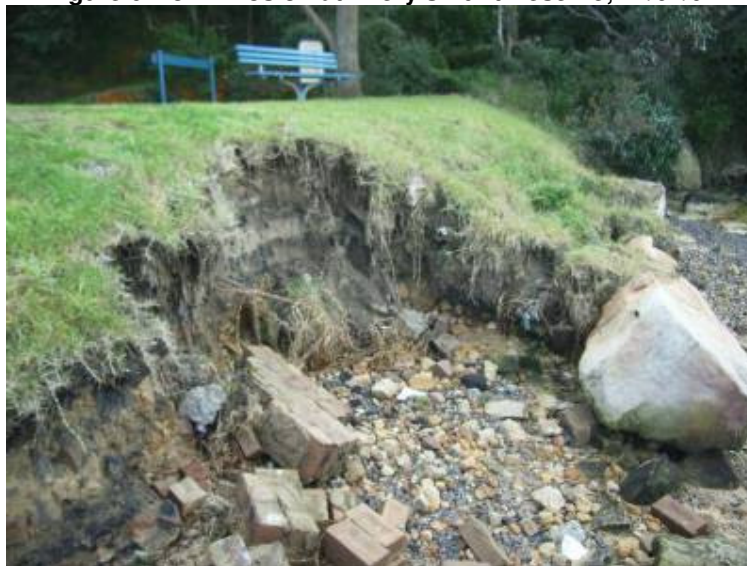
**Figure 6.4.3 – Erosion at Ellery's Punt Reserve, 24/07/07**

There is also erosion occurring that isn't beach or stormwater erosion. For example, where seawalls are collapsing and foreshores are degraded and undergoing erosion. This is evident in the foreshore directly east of Spit Bridge adjacent to Avona Crescent where there is seawall collapse and foreshore erosion.

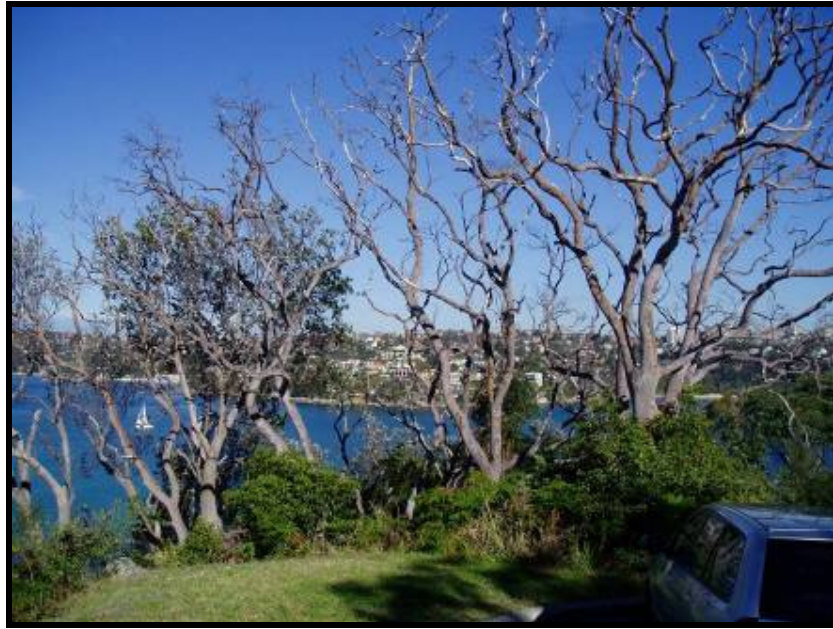
Figure 6.6.3b – Die Back in Bushland above Castle Rock Beach

**Die back** is also an issue in parts of the study area. Die back has been recorded across Australia in native vegetation, and can for a number of reasons, such as changes in drainage, insect attack, poisoning and plant pathogens. One particular plant pathogen, *Phytophthora cinnamomi*, is of great concern. *Phytophthora* is a water mould that occurs in soil and causes root rot in a wide variety of plant species, and often results in the death of the infected plant. The pathogen can be spread by water, contaminated soil on tools, cars, and footwear, allowing it to easily infect surrounding plants once it is in an area. It is difficult to determine whether *Phytophthora* is responsible for the death of plants, so a precautionary approach to the management of die back in bushland is recommended (Skelton et al, 2004).

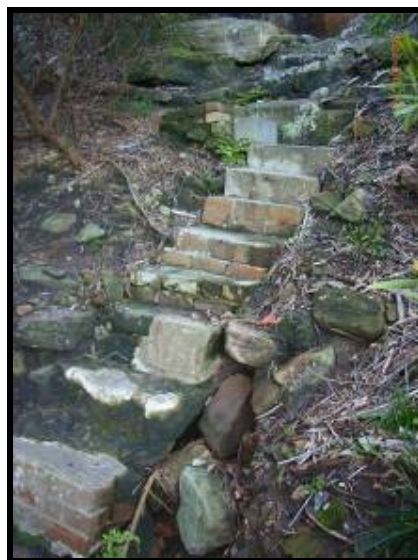
**Figure 6.6.3c – Illegal Pathway between Private Property & the Manly Scenic Walkway**

**Informal pathways** have also had an impact on the bushland within the study area. Pathways have been illegally made to create access to areas such as beaches, formal walking tracks (eg- Manly Scenic Walkway) and recreation areas, with many originating from private properties. These tracks are often not well constructed, and exacerbate problems such as erosion, compaction of soil, and weed dispersal. As many of the tracks are also on Council land, they pose a liability risk to Council. Figure 6.6.3c illustrates the issue, with an illegal pathway that has been created between a private property and the Manly Scenic Walkway, with resultant erosion at the base of the stairs. Some of the existing ad hoc pathways (e.g. Gurney Crescent) are the only way to the foreshore and are very difficult to traverse. An option may be to improve these paths as formal access ways.
